# VEHICLE INSPECTION REPORT

**PE63NFR**

## Daf LF 45.140

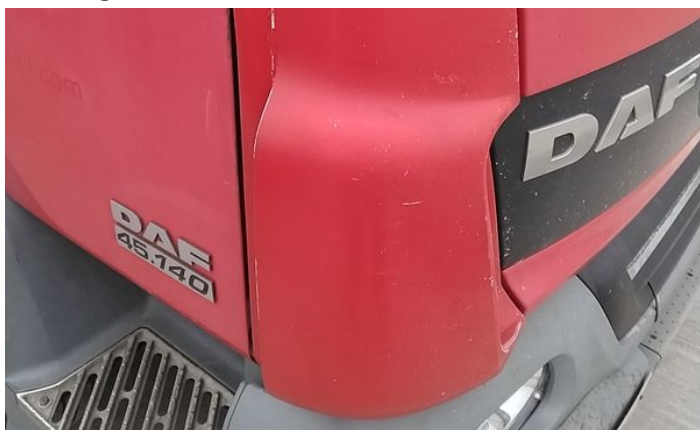
1: Panel Front  
Cracked  
Replace

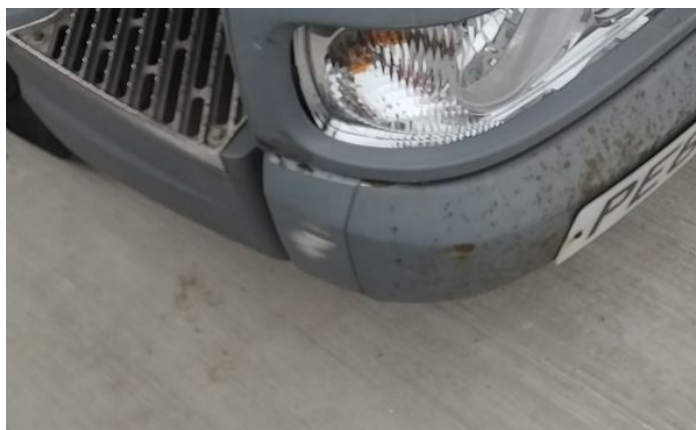
2: Bumper Front  
Scratched  
25 to 100mm Thru Paint

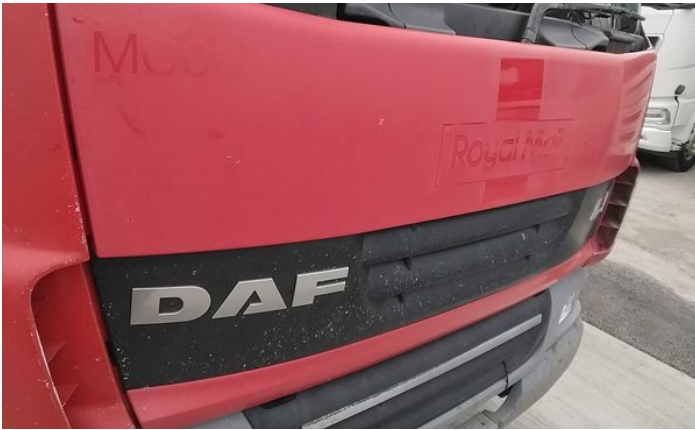
3: Bonnet  
Chipped  
Multiple Chips

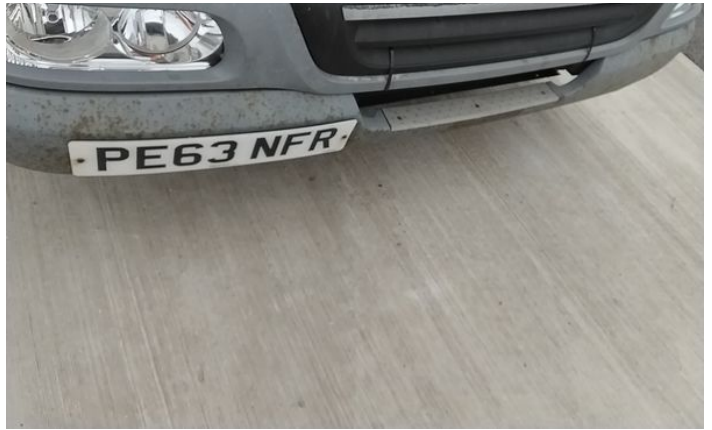
4: Bumper Front  
Rusted  
Over 5mm

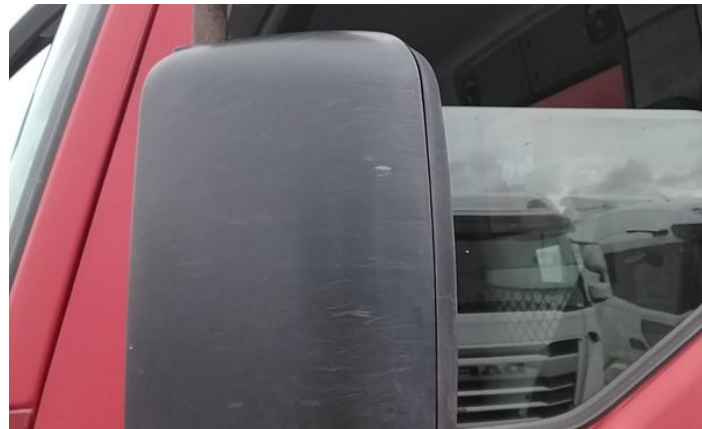
5: Door Mirror Assy nsf  
Scuffed (Unpainted)  
Over 100mm

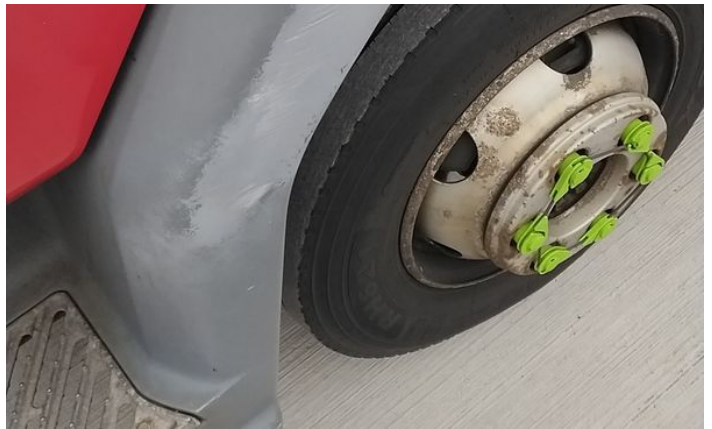
6: Wing nsf  
Poor Previous Repair  
Rippled Up To 30%

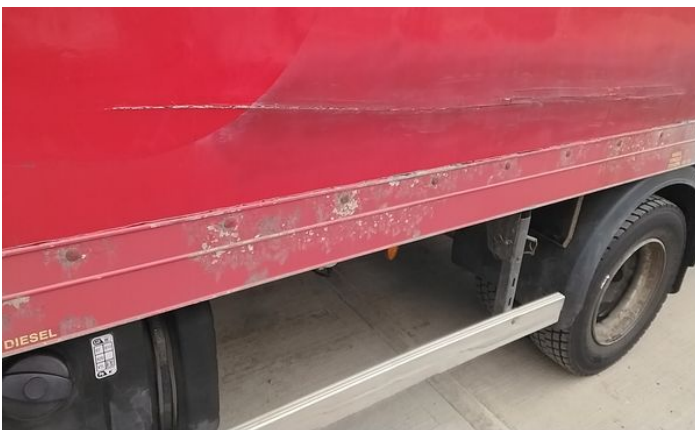
7: Qtr Panel nsr  
Cracked  
Replace

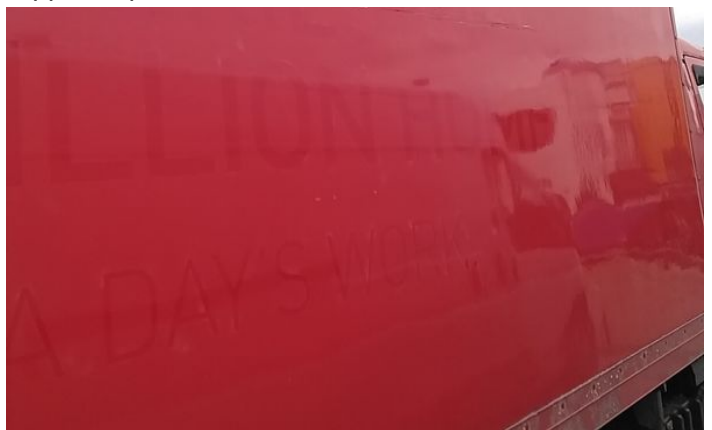
8: Qtr Panel osr  
Scratched  
Over 25mm Thru Paint

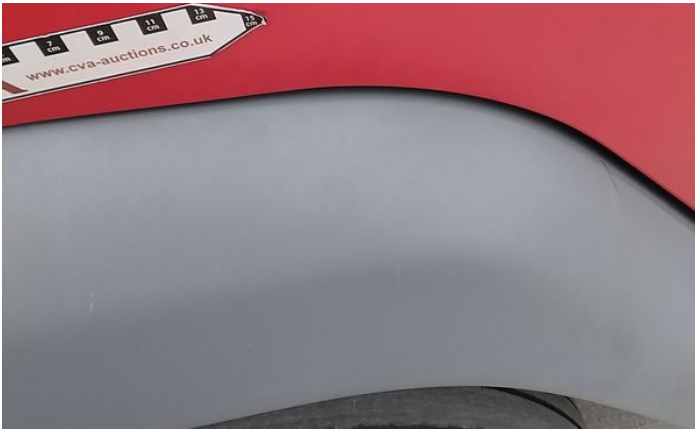
9: Door osf  
Dented  
Over 30mm

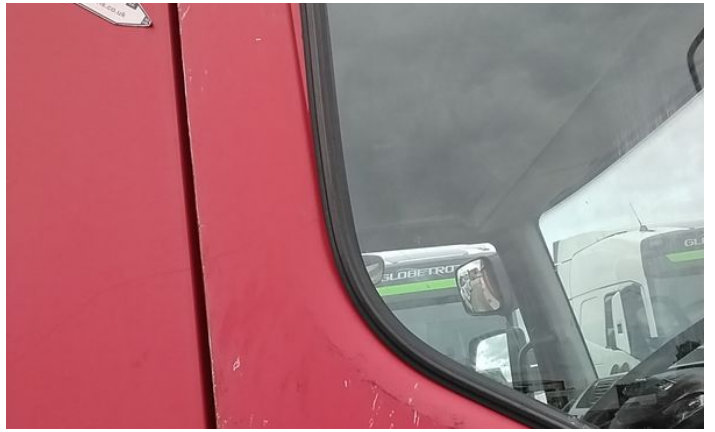
10: Door osf  
Scratched  
Over 25mm Thru Paint

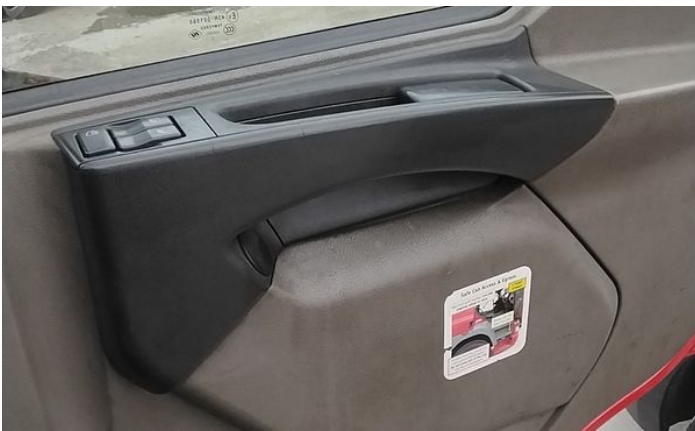
11: Door Pad osf  
Soiled  
Heavy

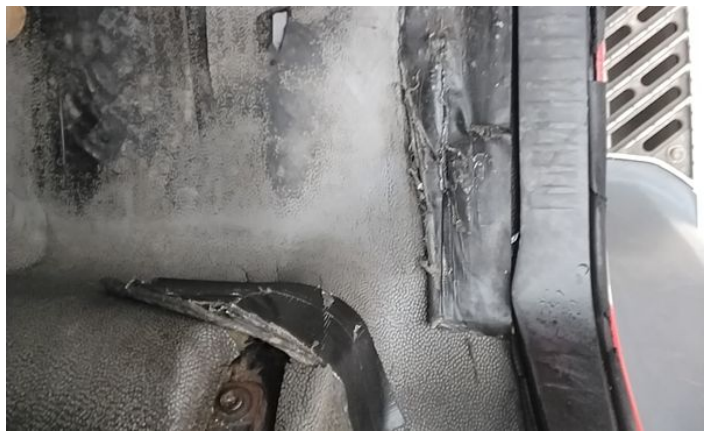
12: Carpets Front  
Holed  
Over 3mm

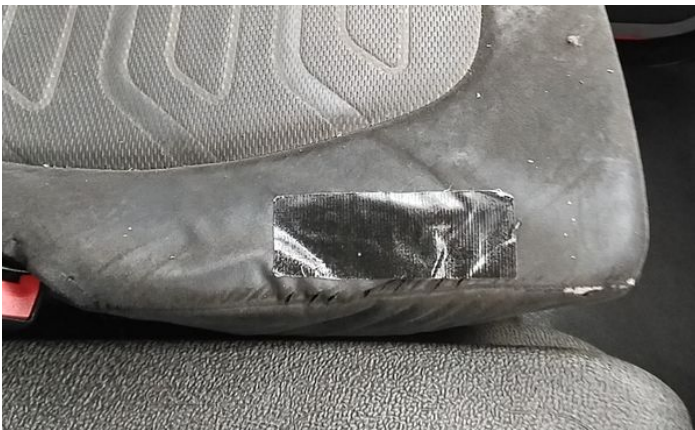
13: Seat Base Cover nsf  
Holed  
Over 3mm
